INSPECTION REPORT

2512 STONE MOUNTAIN DRIVE
DENTON, TX 76210

Roof Condition Evaluation

TIER 2 EVALUATION

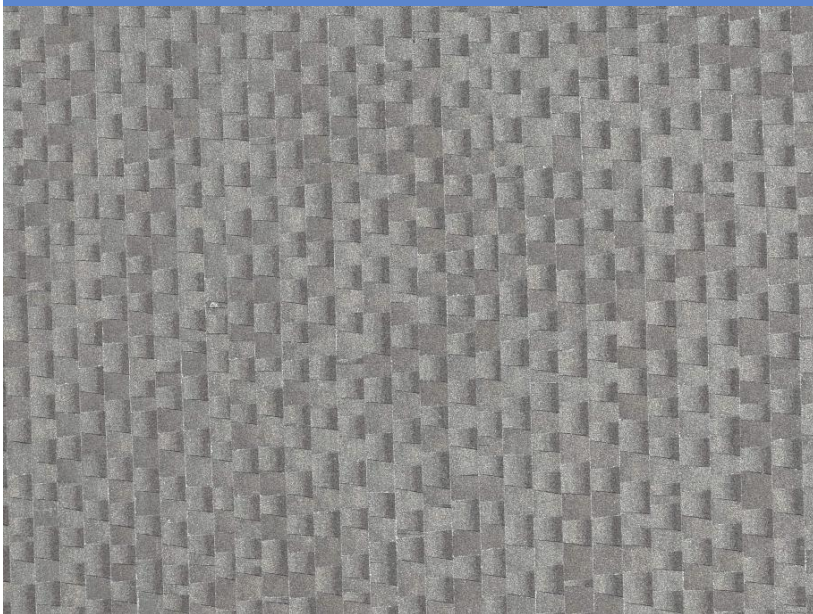
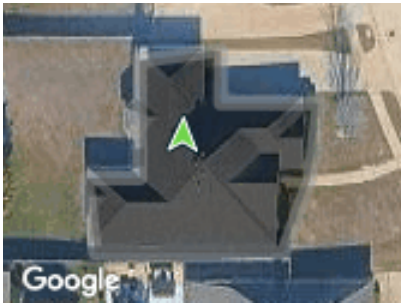
**DC010**

Buck Broadhead
03/30/2026 2:19 PM CDT
Hail Damage & Significant Deterioration

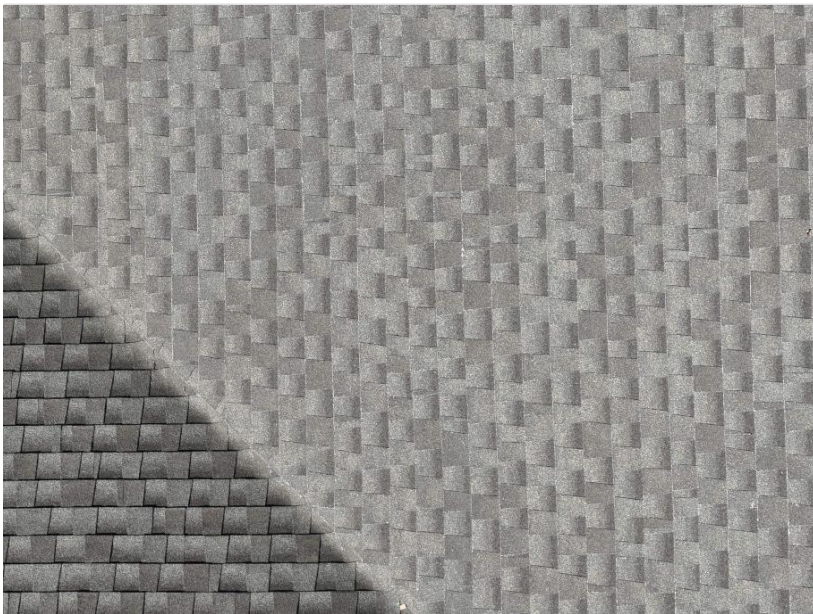
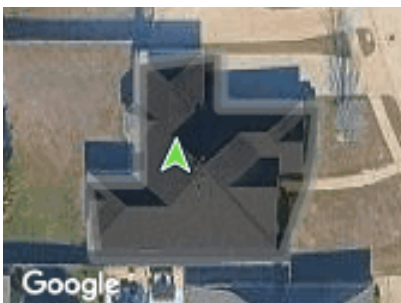
**DC011**

Buck Broadhead
03/30/2026 2:20 PM CDT
Hail Damage & Significant Deterioration

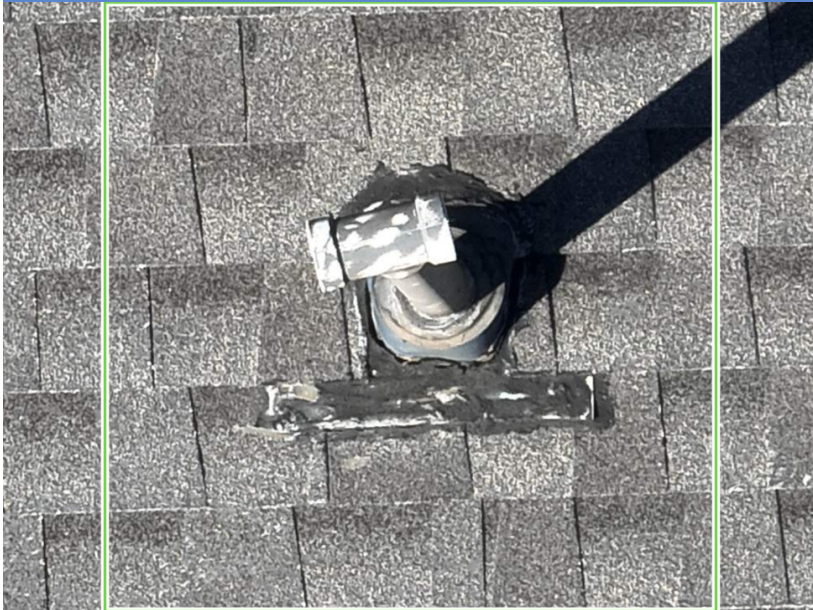
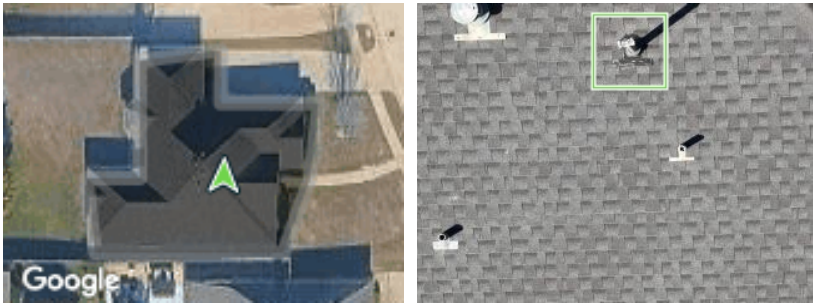
DC019-1 OTHER

Buck Broadhead
03/30/2026 2:24 PM CDT
High risk for leak

Penetration Sealing — Immediate
 Caulking and resealing of all roof penetrations (pipe boots, vent flashings, exposed seams) is recommended as a near-term protective measure. This addresses the primary active leak-risk locations identified during inspection and is advisable independent of longer-term planning decisions.

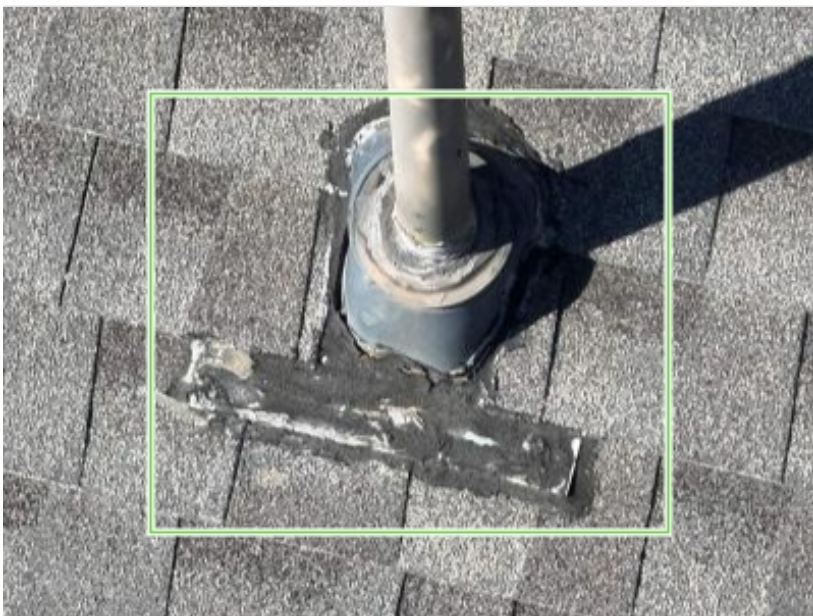
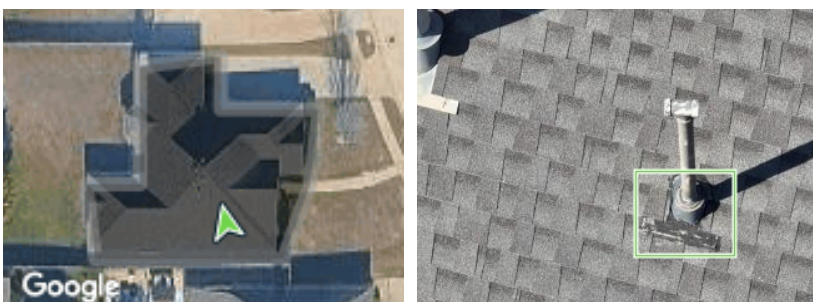
PO010-1 OTHER

Buck Broadhead
03/30/2026 2:28 PM CDT
Old sealant - leak prone

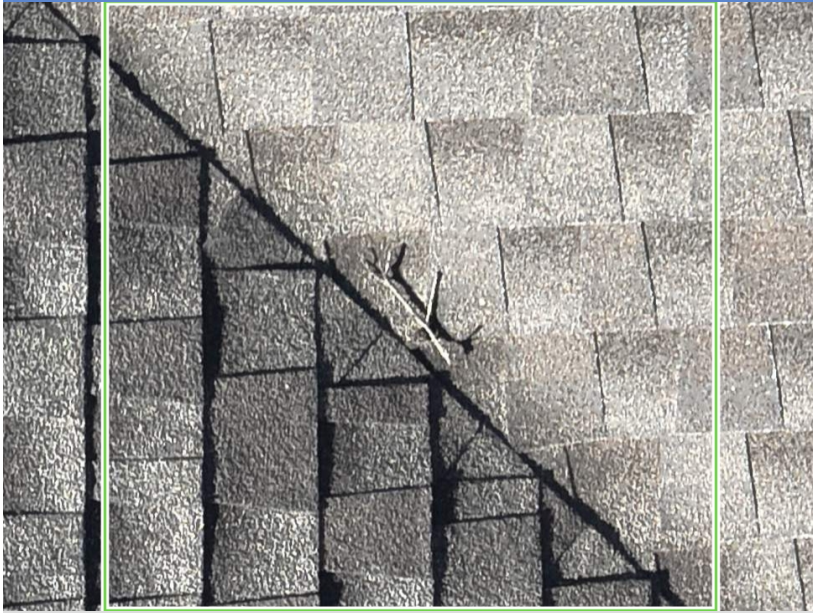
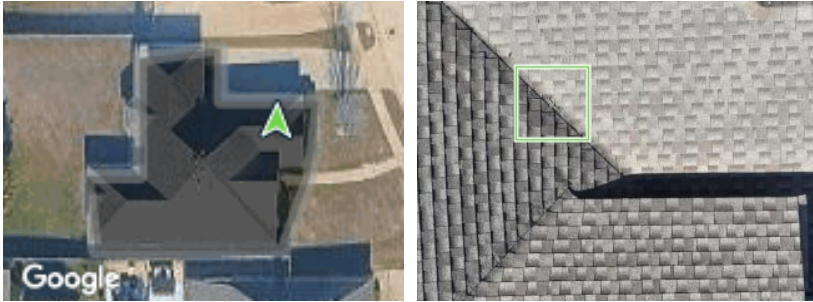
DC024-1 OTHER

Buck Broadhead
03/30/2026 2:25 PM CDT
High risk for leaks

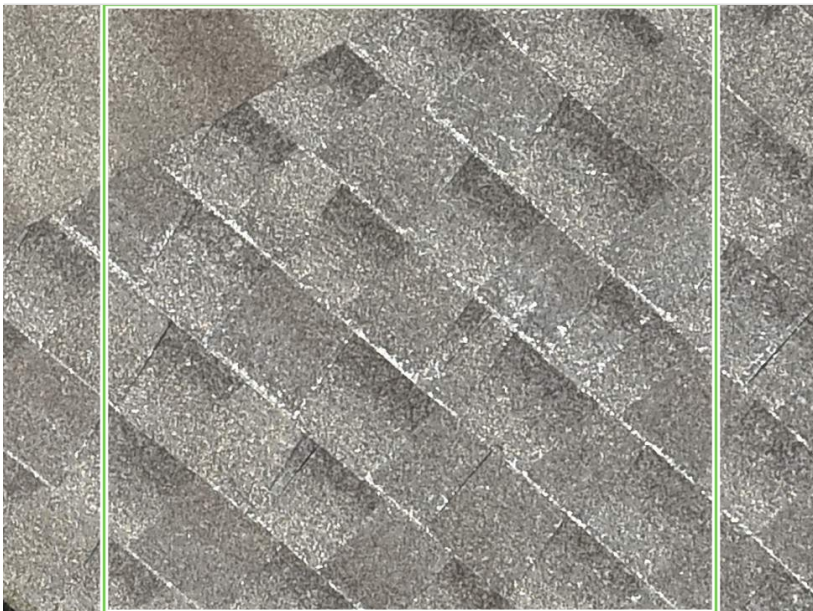
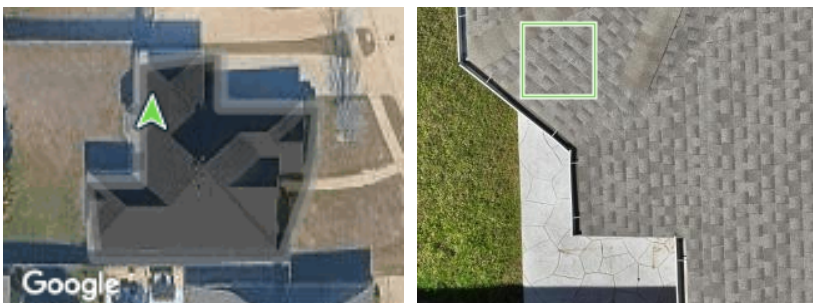
DC004-1 OTHER

Buck Broadhead
03/30/2026 2:16 PM CDT
Granule loss / deterioration. Exposed
fiberglass

Shingle-Level Repairs — Not Advisable
 Due to the current brittleness of the shingle material, isolated patch repairs are not recommended. Attempted repairs carry a measurable risk of causing additional fracturing to surrounding shingles. Interested parties should factor this into condition-based planning.

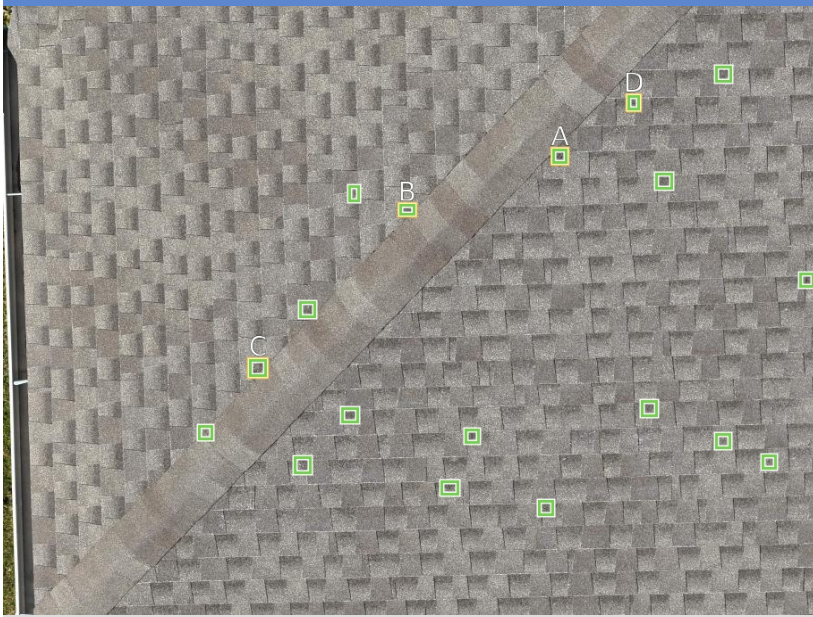
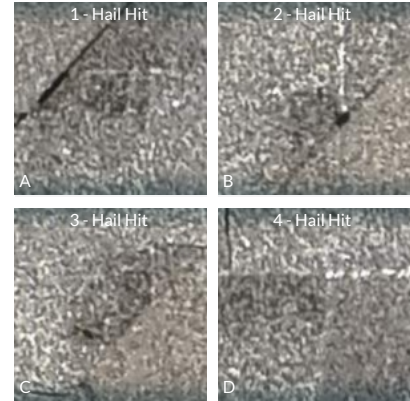
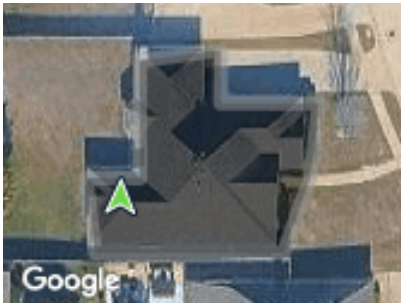
DC002

Hail Hit 18

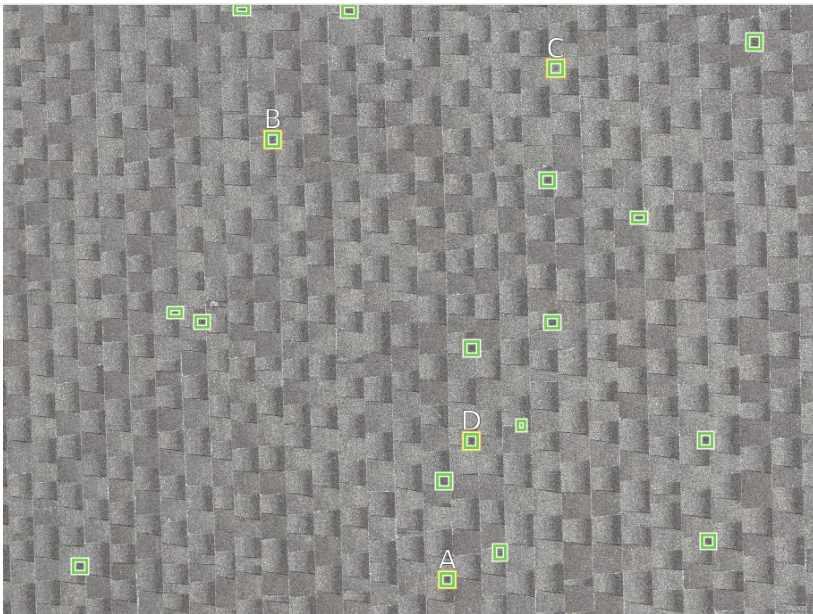
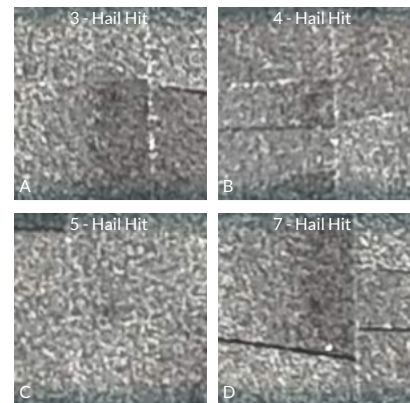
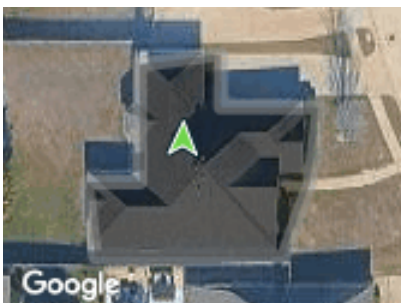
DC010

Hail Hit 19

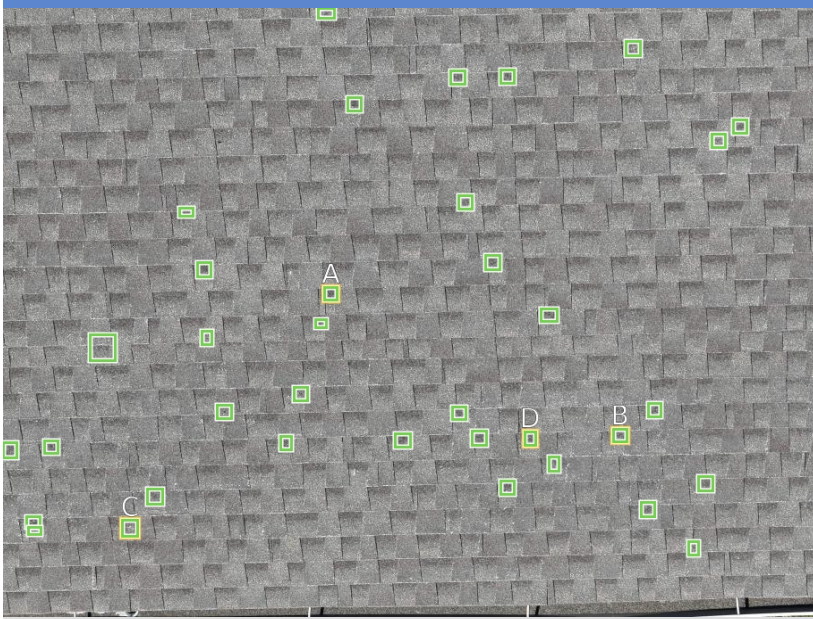
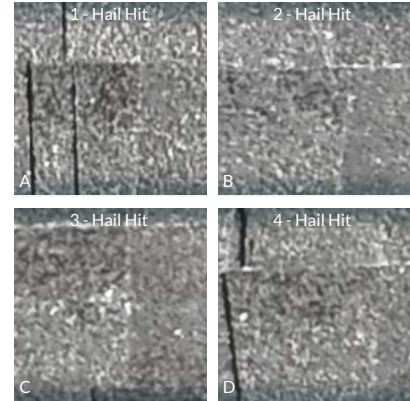
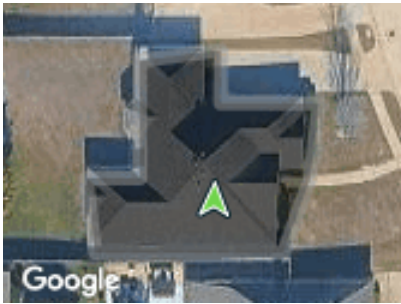
DC017

Hail Hit 36

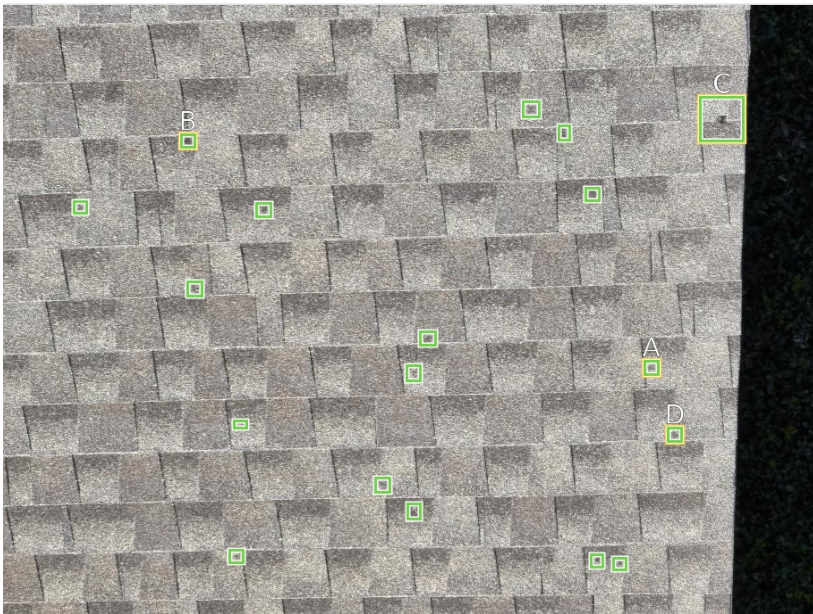
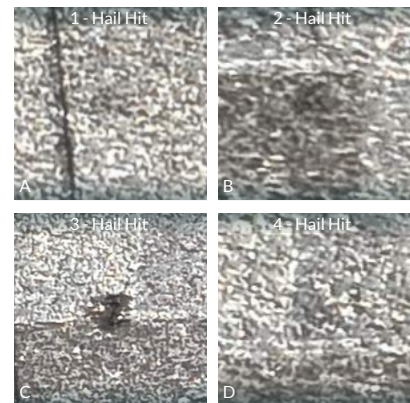
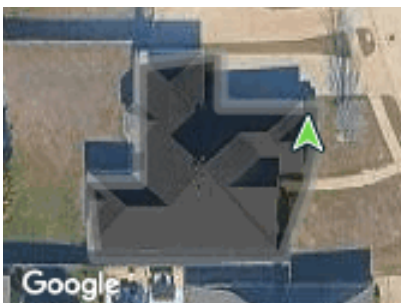
PO001

Hail Hit 18

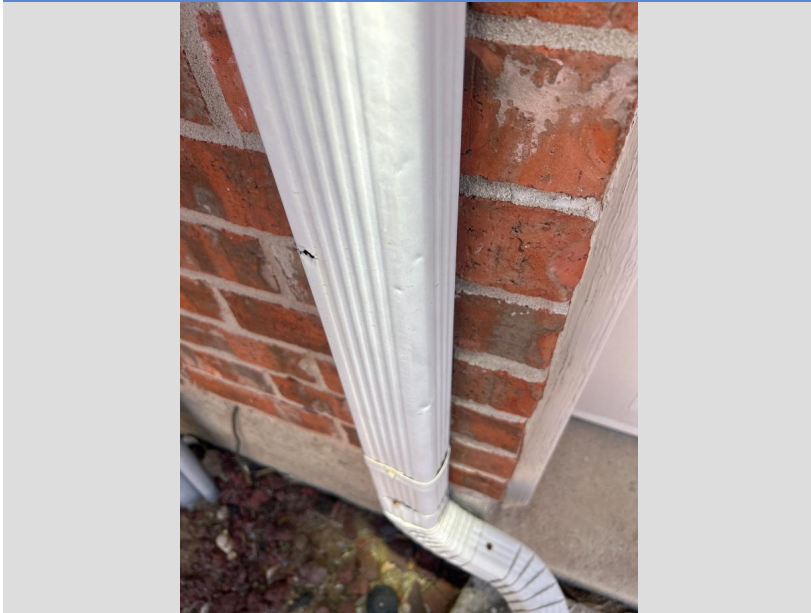
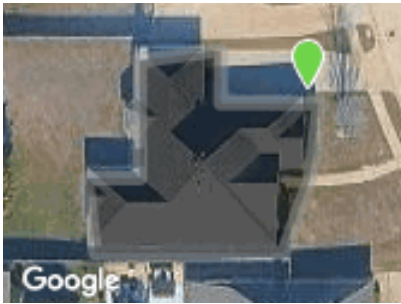
AT018

Buck Broadhead
03/30/2026 2:30 PM CDT
Consistent hail & mechanical damages to
gutter system

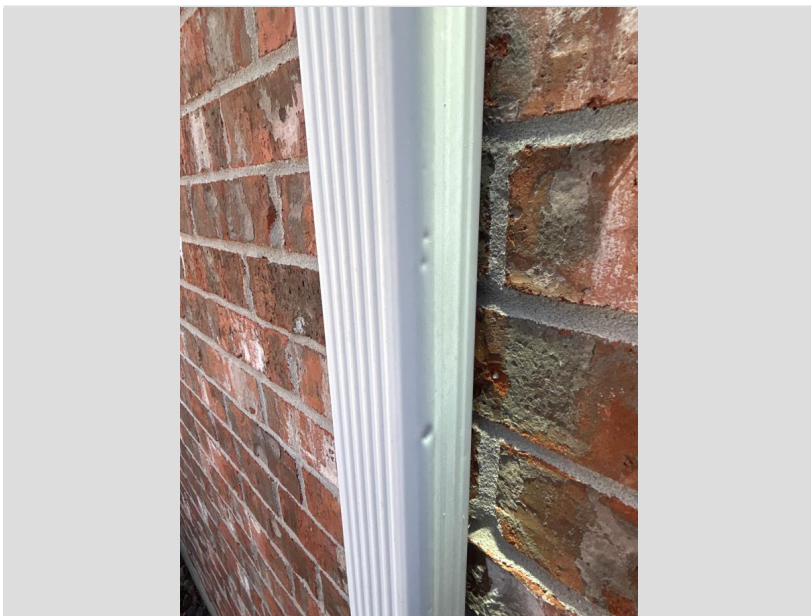
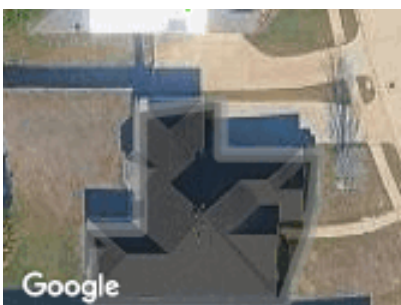
AT041

Buck Broadhead
03/30/2026 2:32 PM CDT
Additional documentation of hail damage to
gutter system

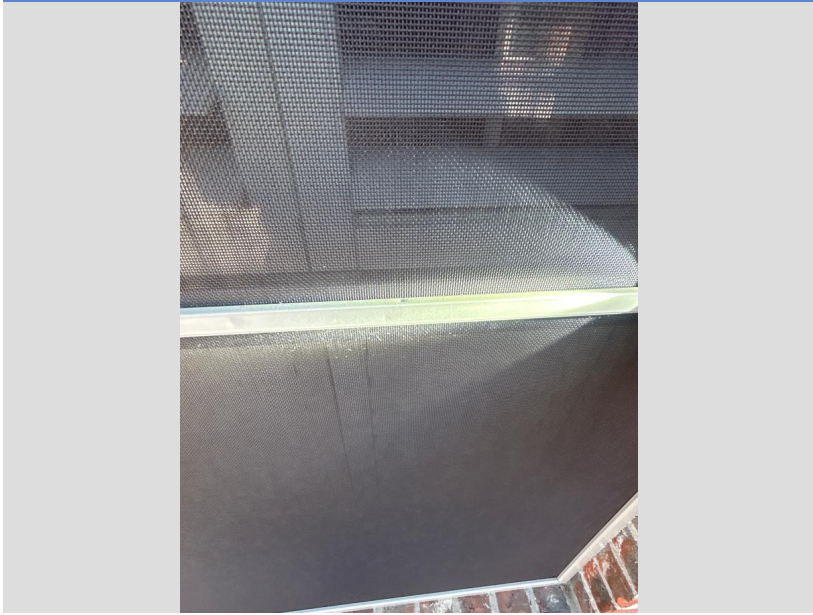
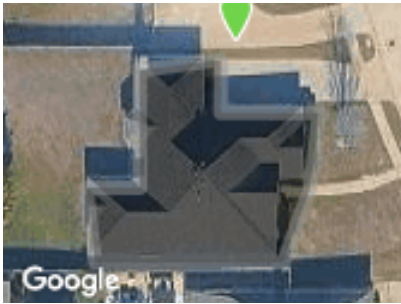
AT024

Buck Broadhead
 03/30/2026 2:31 PM CDT
 Hail hits to window screens

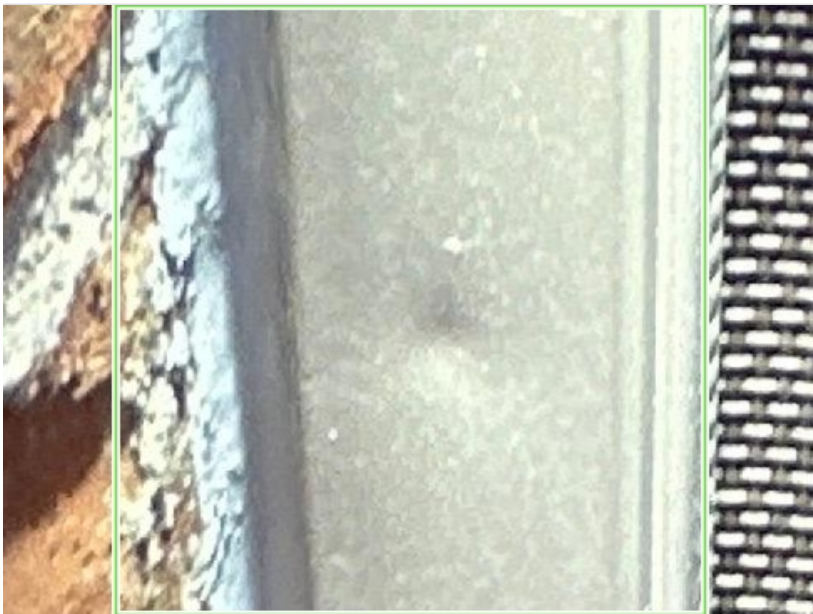
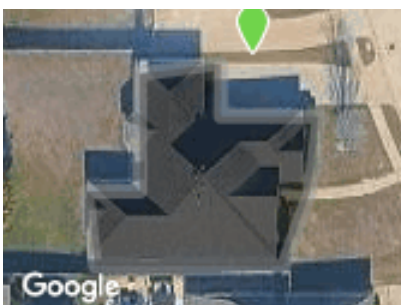
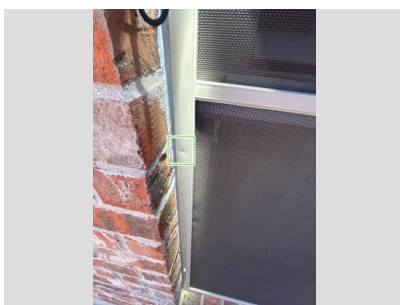
AT025-1 HAIL

Buck Broadhead
 03/30/2026 2:31 PM CDT
 Consistent hail to window screens

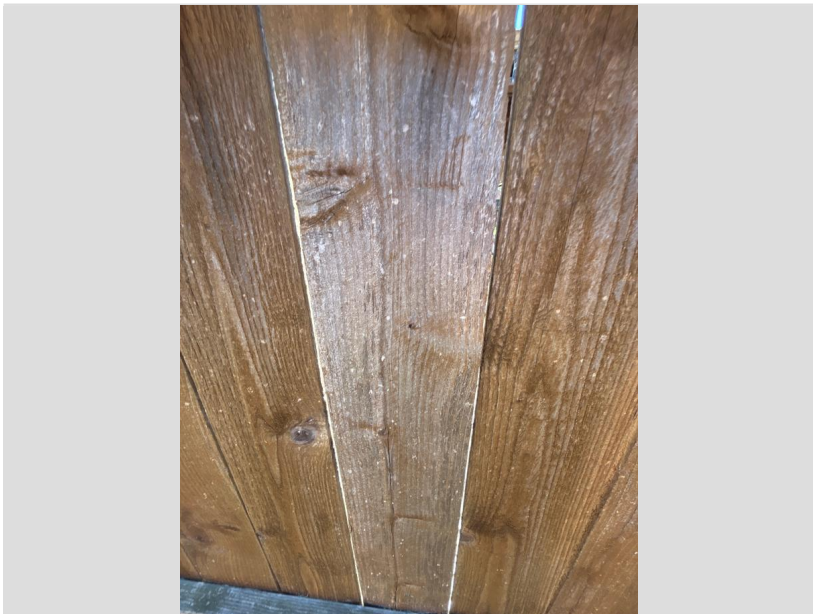
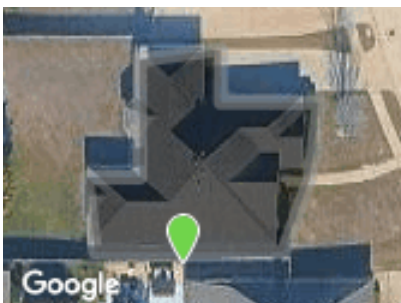
AT076

Buck Broadhead
03/30/2026 2:34 PM CDT
Additional hail damage to the fence stain
